AC 2008-1977: THE PROBLEM OF GROUNDWATER AND WOOD PILES IN BOSTON, AN UNENDING NEED FOR VIGILANT SURVEILLANCE

James Lambrechts, Wentworth Institute of Technology

Abstract

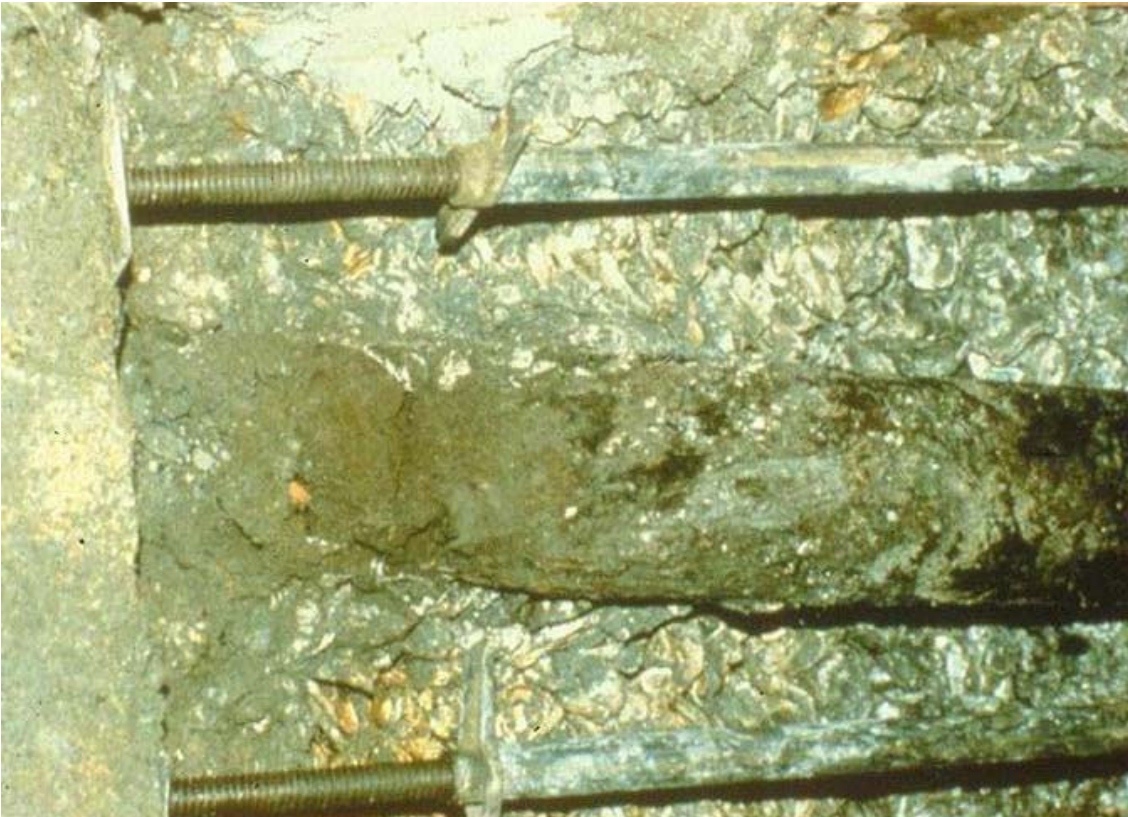
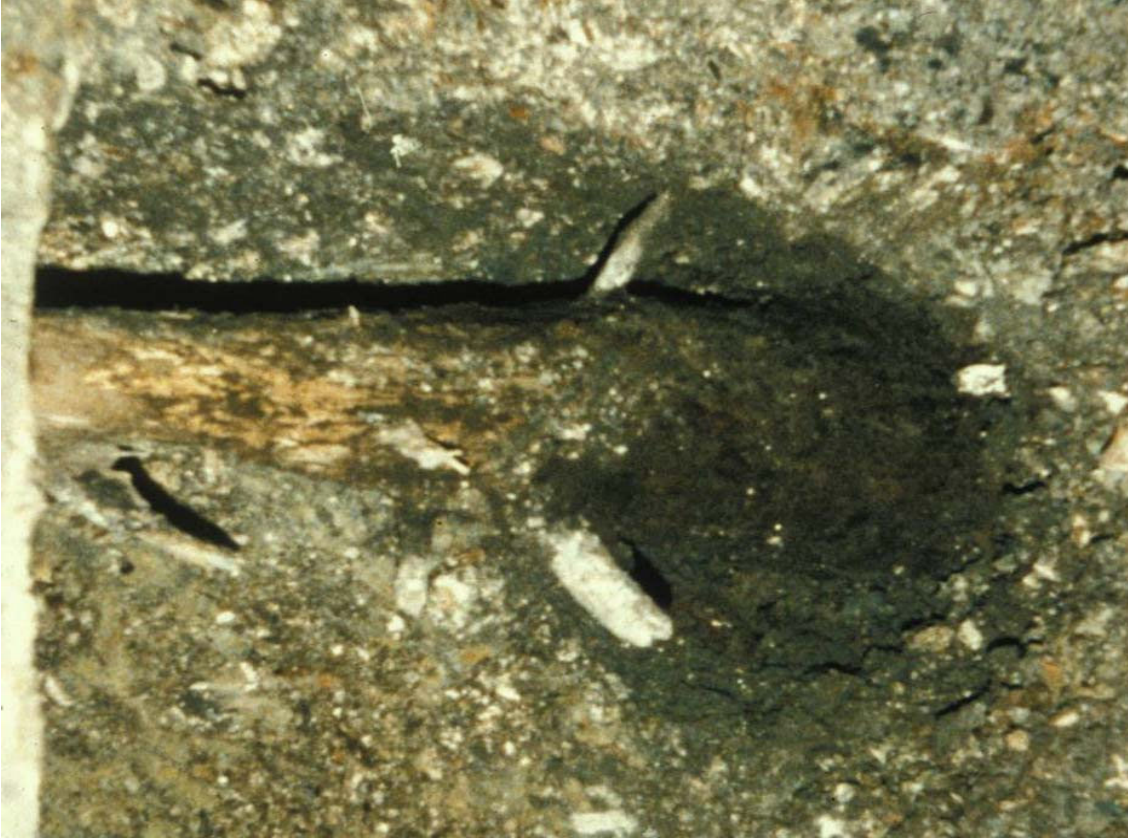
Figure 1. Examples of Wood Piles That Have Suffered Substantial Rotting

The major problem with wood piles occurs when groundwater levels drop and expose the wood at the top of the pile to air, which will trigger spores of fungi that are naturally in the wood to produce the wood rotting organisms. Once started, the fungi will slowly and steadily work through the wood cell structure and cause the wood to progressively weaken, eventually to the point where there is not enough sound wood left to support building loads. The rotting seen most often works its way from the perimeter in towards the center of the wood pile. In some instances it may take only a few years for most of the pile top to rot away, but in other cases it may take a few decades, and the rate will often vary from pile to pile (or from tree to tree). Figure 1 illustrates the damage that can occur, with one pile being substantially decayed to the consistency of peat moss over its top two feet, and the other having lost all but 1 inch of its top diameter to rot (the horizontal 'pegs' show where the tree branches were, and illustrate the original diameter of the tree/wood pile).

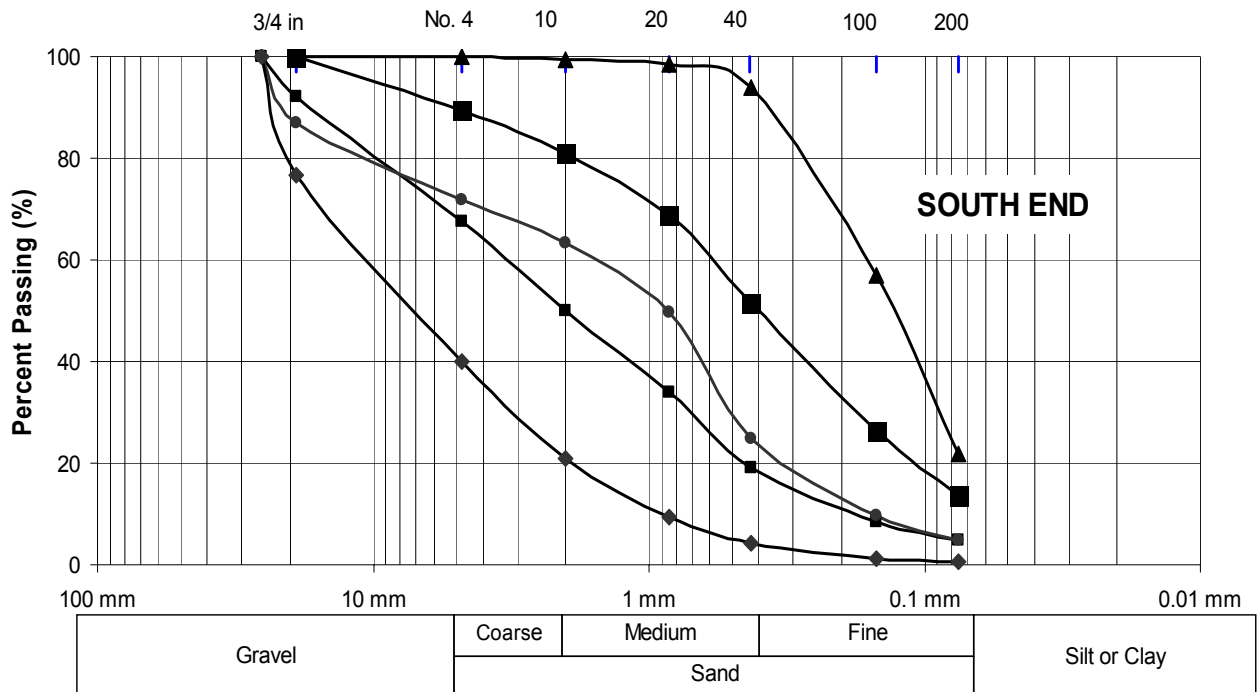
Figure 12. Grain Size Analysis on Samples of Fill Stratum

To design recharge systems, information is necessary on the permeability of the Fill stratum and the depth of Fill above the underlying impervious stratum. An initial research effort was undertaken in 2006 by two civil engineering seniors Wentworth as a special topics study course in which they characterized the granular fill in two neighborhoods¹³. Soil samples retrieved from Standard Penetration Tests made during observation well installations were tested by sieve and hydrometer analysis to determine the gradation of the fill. Results of some tests are shown on Figure 12 as grain size distribution of several samples from the South End, and then as a summary graph comparing distribution of various samples for the granular soil characterization. The fill has been found to be of fairly consistent gradation throughout most of the Back Bay neighborhood, but shows great variability in the South End with several samples having substantial amount of fines (minus No. 200 sieve). Further testing to characterize the fill in other neighborhoods is expected to be taken up by two seniors this coming year who will also attempt permeability tests on composite samples of same gradation. The intent is to develop reasonable ranges for fill permeability in the various neighborhoods, and provide guidance on correlations of grain size and permeability. This is an important parameter for geotechnical engineers and hydrologists who will design future recharge systems.
