# Biodegradation of Untreated Wood Foundation Piles In Existing Buildings Part 1 – Investigation

By Milan Vatovec, P.E., Ph.D. and Paul L. Kelley, P.E.

When wood foundation piles deteriorate, they can become incapable of supporting the buildings founded on them. This article, Part 1 of a 3-part series on pile biodegradation, discusses the available investigative techniques aimed at quantifying, understanding, and preventing biological deterioration of untreated wood foundation piles that result in settlement of numerous buildings in historic cities throughout the U.S.

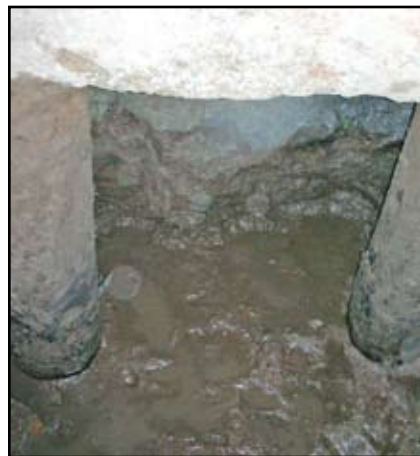
Figure 2: To access the piles, dewatering is often required. Depending on the pit size, only a limited number of piles can be accessed.

Once exposed (Figure 2), an engineer must evaluate the condition of the piles and the prevailing environment in order to extrapolate the findings to the remaining piles and to the building as a whole. This is often a difficult task, given

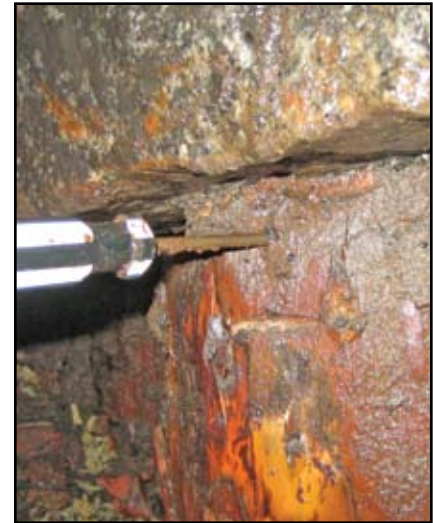
Figure 3: Piles should be probed from various angles and penetration depths should be recorded.

Piles should be probed in a systematic manner with a sharp object, and depths of penetration recorded (Figure 3, see page 9). In addition, piles should be cored at various locations (Figure 4) to extract samples (usually 1/4 or 1/2 inch diameter cores through the pile center) for subsequent laboratory work. Also, to determine the relative remaining strength of the pile in situ, a resistograph, a core-boring instrument that registers the “resistance” of the core as it is penetrating

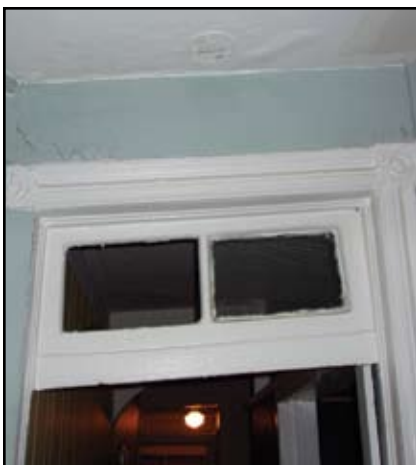
Figure 1: Cracks over doors or floor/frame misalignments are usually good indicators of settlement problems.

Detection and quantification of settlement problems is not simple. For example, if numerous stepped cracks in exterior masonry, sloped floors, and uneven door frames are observed (Figure 1), it can be reasonably concluded that the building is likely experiencing differential settlement. Combining these observations with the knowledge that the building is supported by untreated piles (if drawings are available), and that it is located in a known groundwater-depletion area, one can start to suspect

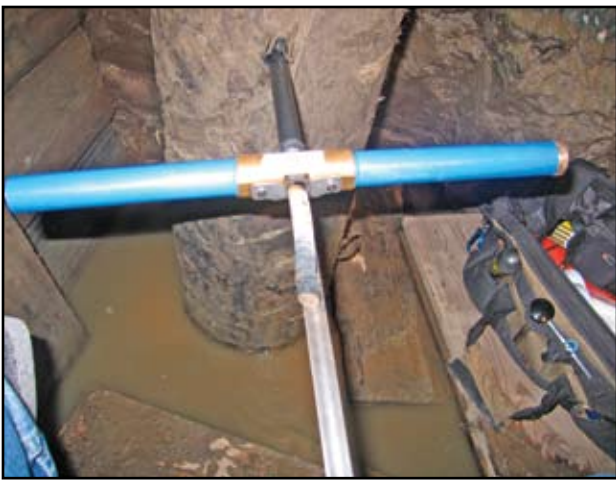
Figure 4: Due to limited access to piles, only a limited number of cores can be obtained.

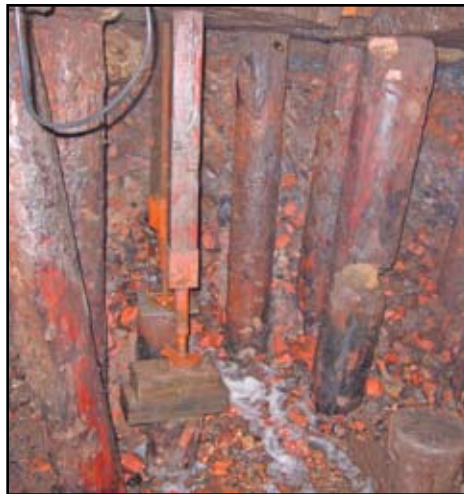
Figure 5: Removal is often difficult because the pile may be carrying significant load. The underside of the pile cap may require shoring to maintain stability.

If possible, entire pile cross sections, approximately 2-3 feet long, can be extracted and taken to the laboratory for additional testing (Figure 5). Temporary shoring may be needed during this operation, depending on the stability of the granite or other foundation elements above the cut pile. After extraction of the pile top, the remaining pile “stub” can be load-tested in accordance with ASTM standards to estimate the overall load-carrying capacity of the foundation system. Using the pile cap as a reaction, loads (applied by hydraulics) and deflections can be continually measured until the pile can no longer take additional load.

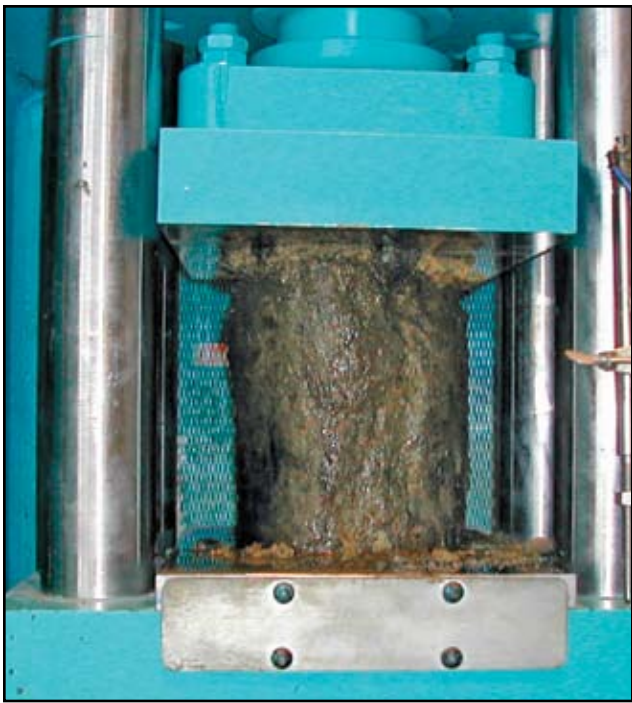
Figure 9: Load test of a full pile cross section.

Additionally, entire pile cross sections can be tested in compression until failure (Figure 9, see page 12). These tests can be good indicators of the remaining strength of the pile, but determination of the remaining stiffness, often the critical element to understand the potential for settlement, can be difficult if variable zones of soft, deteriorated wood exist across the cross section. If only one pile cross-section is obtained in the field, doing a number of small-clear specimen compressive tests will usually yield better and more comprehensive information than doing one full-section test.
