WATER-TABLE MAP, SEPTEMBER 20-21, 1967

GROUND-WATER LEVELS ON BOSTON PENINSULA, MASSACHUSETTS

By  
John E. Cotton and David F. Delaney  
1975

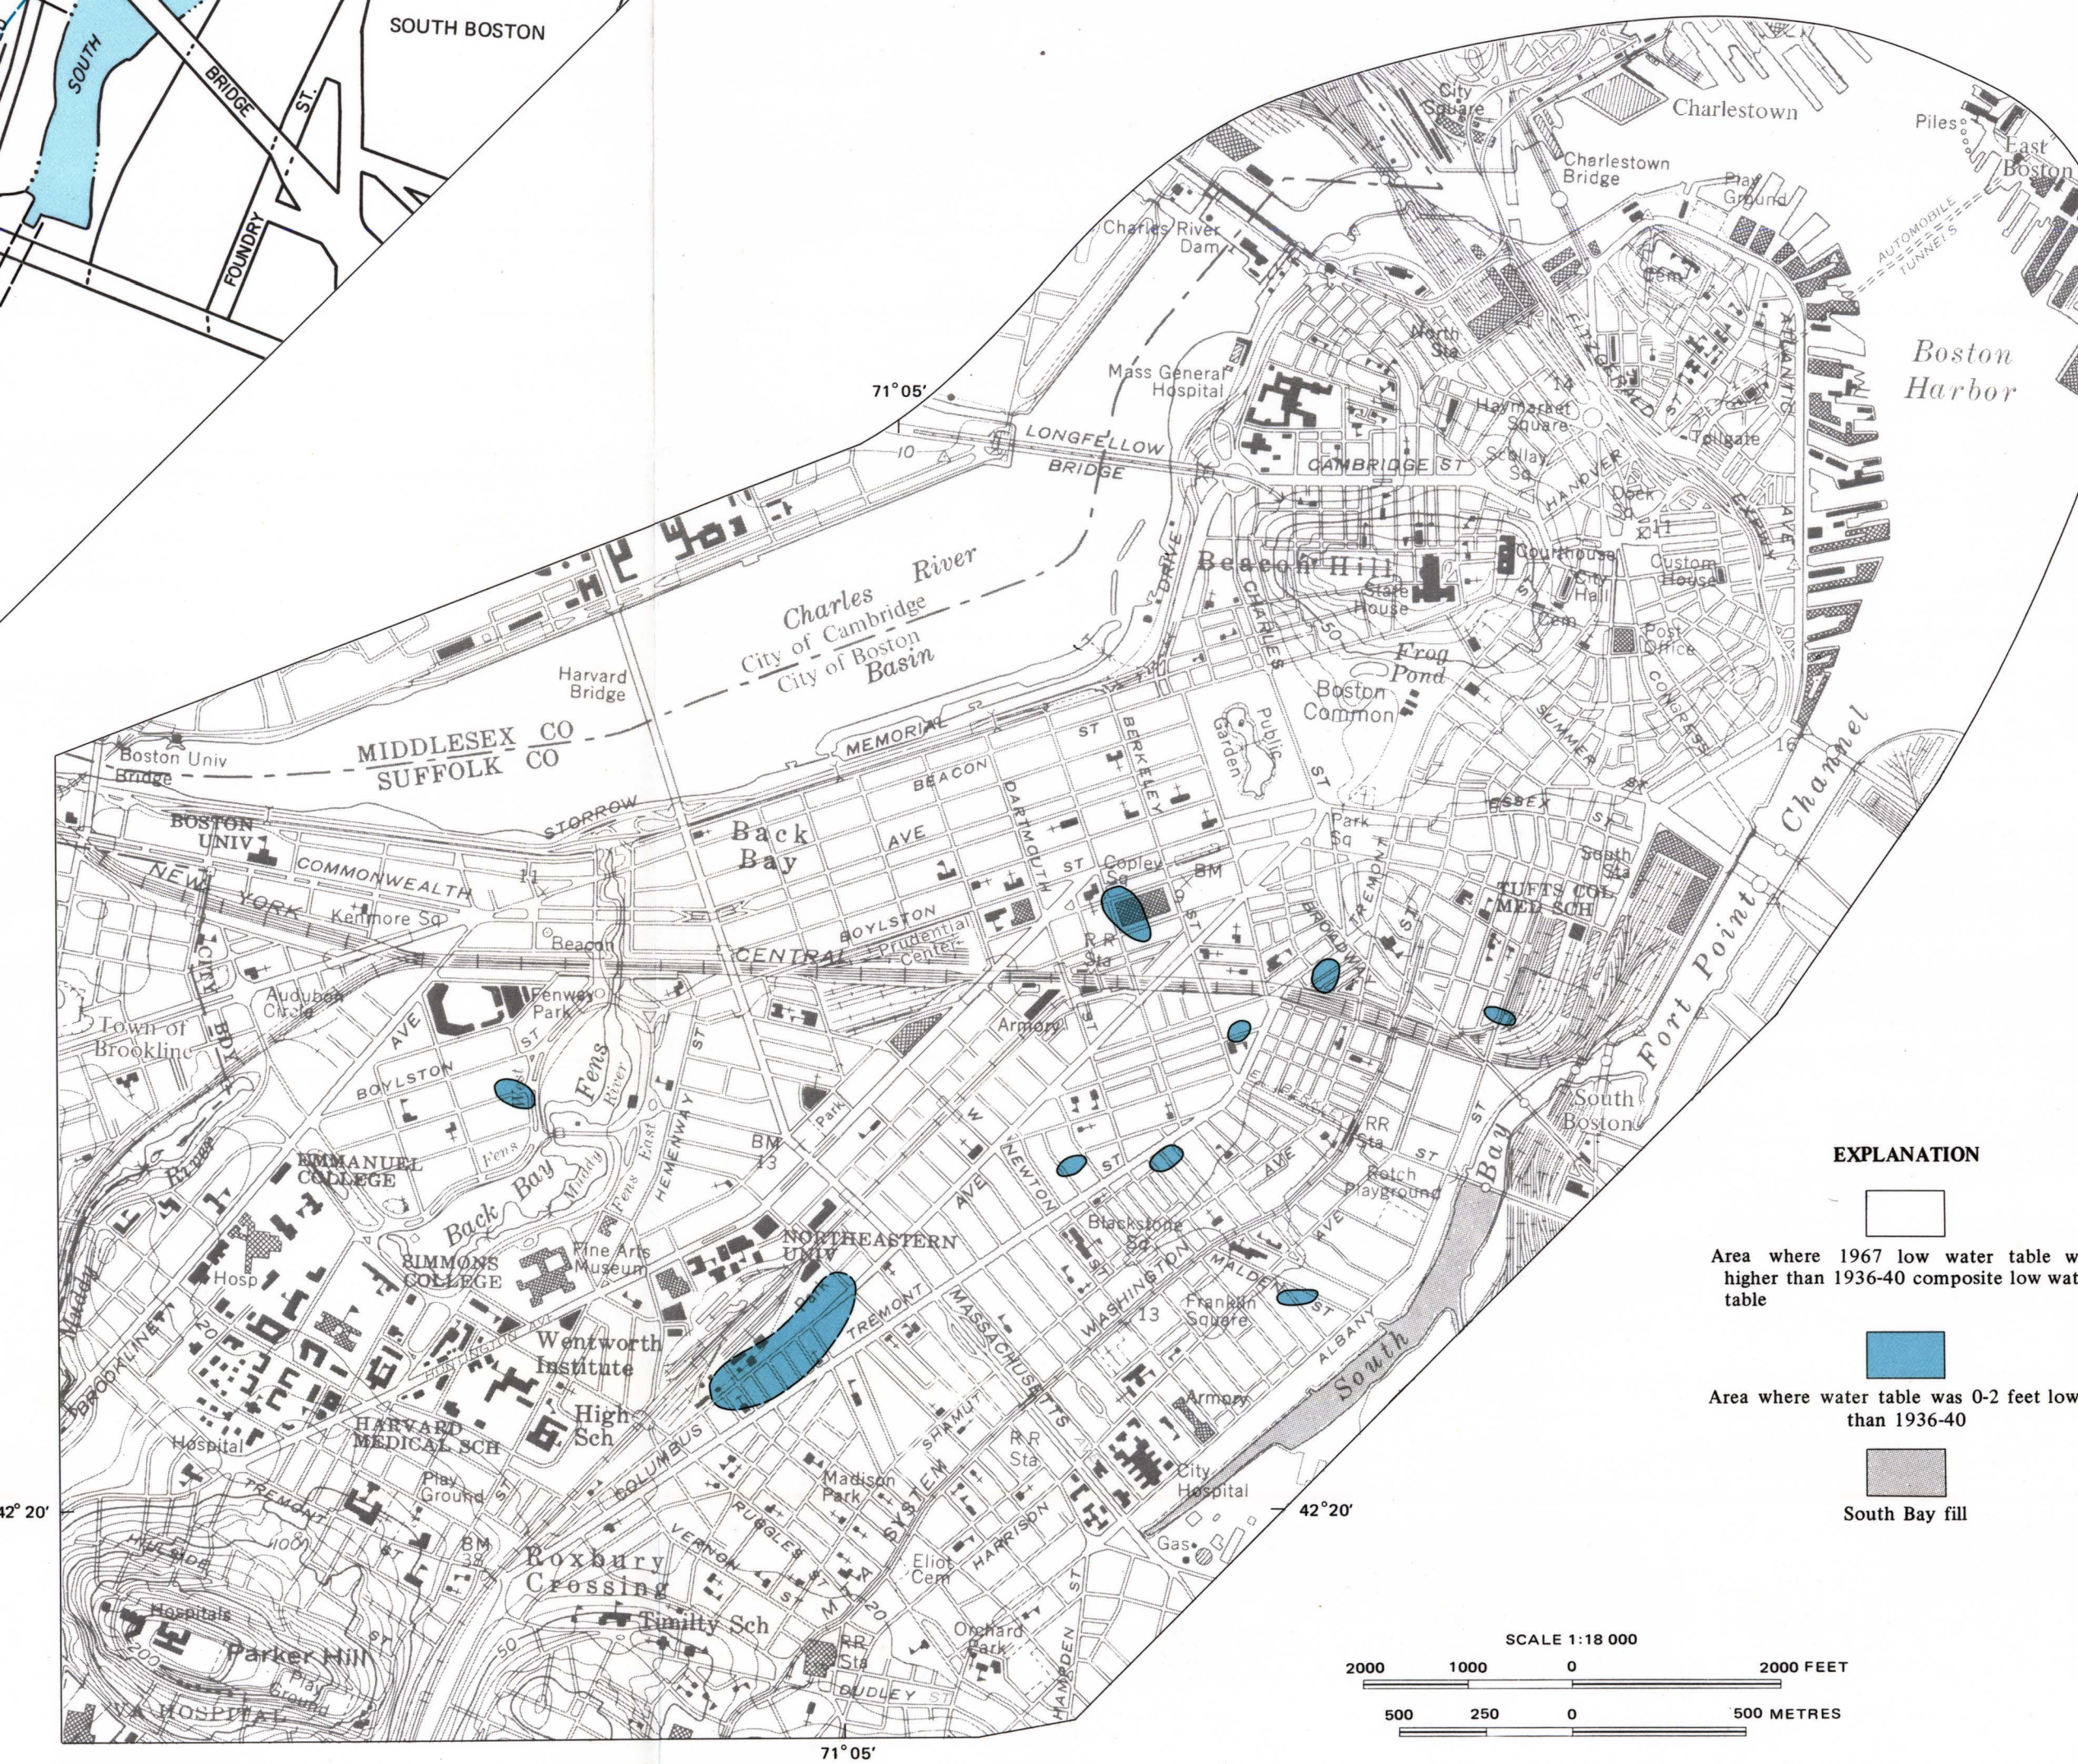
FIGURE 6.—MAP SHOWING AREAS WHERE THE SEPTEMBER 20-21, 1967, WATER TABLE WAS LOWER THAN THE 1936-40 COMPOSITE LOW WATER TABLE.

**LOW WATER-TABLE COMPARISON (1936-40 and 1967)**  
In September 1967 the underlying sand and gravel in the old Gravelly Point area was saturated, and the water table was not perched, as indicated by the composite low water-table map for 1936-40.  
The water table in the area south of the Metropolitan District Commission sewer along Storrow Memorial Drive is generally higher than those on both of the 1936-40 maps. There may have been more ground-water movement through the wooden sheeting along the sewer in 1967. If the sheeting had partly rotted, water from the Charles River Basin could have recharged this area of Back Bay more effectively.  
The troughlike low along Tremont Street was more clearly defined in 1967 than on the 1936-40 map and demonstrates an area of discharge.
