REPORT ON
GROUNDWATER IN BACK BAY BOSTON
BOSTON, MASSACHUSETTS

for
Boston Redevelopment Authority
Boston, Massachusetts

7 March 1985
File No. 5381

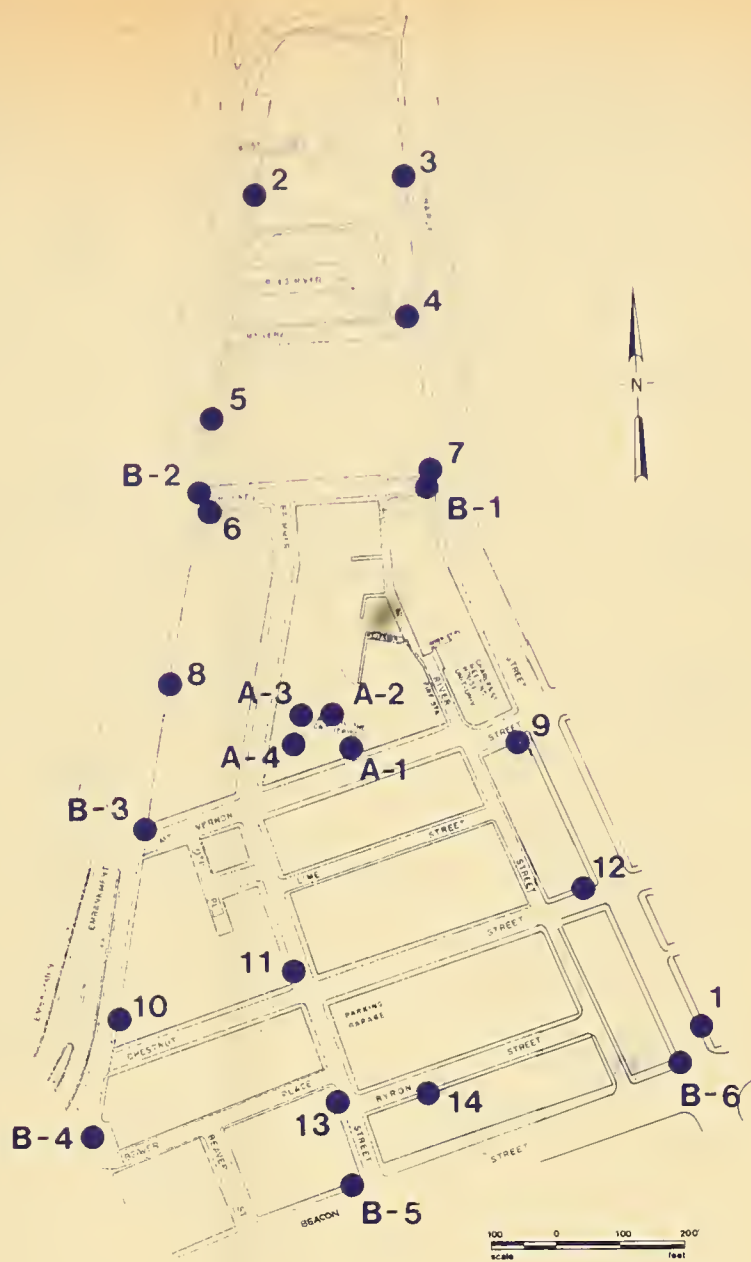
FIGURE 3

- 8 LOCATION OF WPA OBSERVATION WELL
- C-2 LOCATION OF OBSERVATION WELL INSTALLED AND MONITORED FOR OTHER PROJECTS.

Groundwater level data are available from hundreds of observation wells which have been installed throughout the study area in the past 50 years. Observation well locations are shown on drawings for each of seven zones in the study area, Figures 3 through 9. The data are presented in Figures 10 through 16 as ranges of water level elevation in each well.

The location of each observation well used in this study is indicated by zone in Figures 3 through 9.

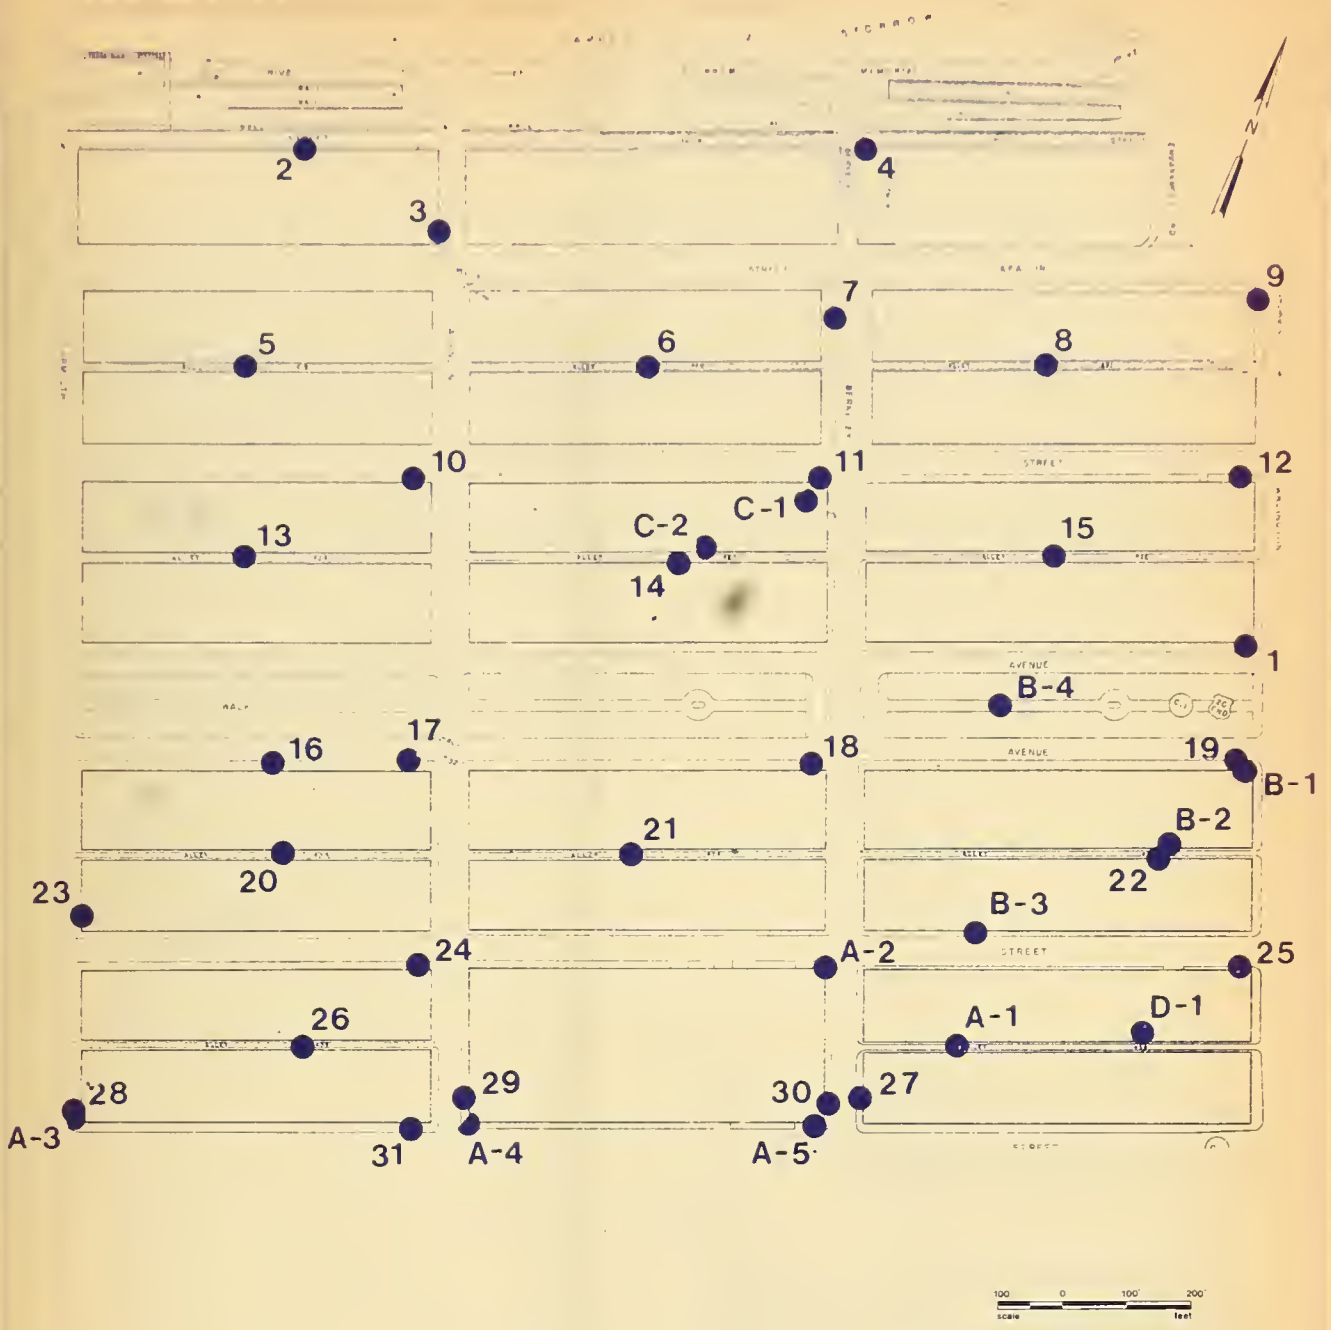
FIGURE 4

- 6 LOCATION OF WPA OBSERVATION WELL
- C-2 LOCATION OF OBSERVATION WELL INSTALLED AND MONITORED FOR OTHER PROJECTS.

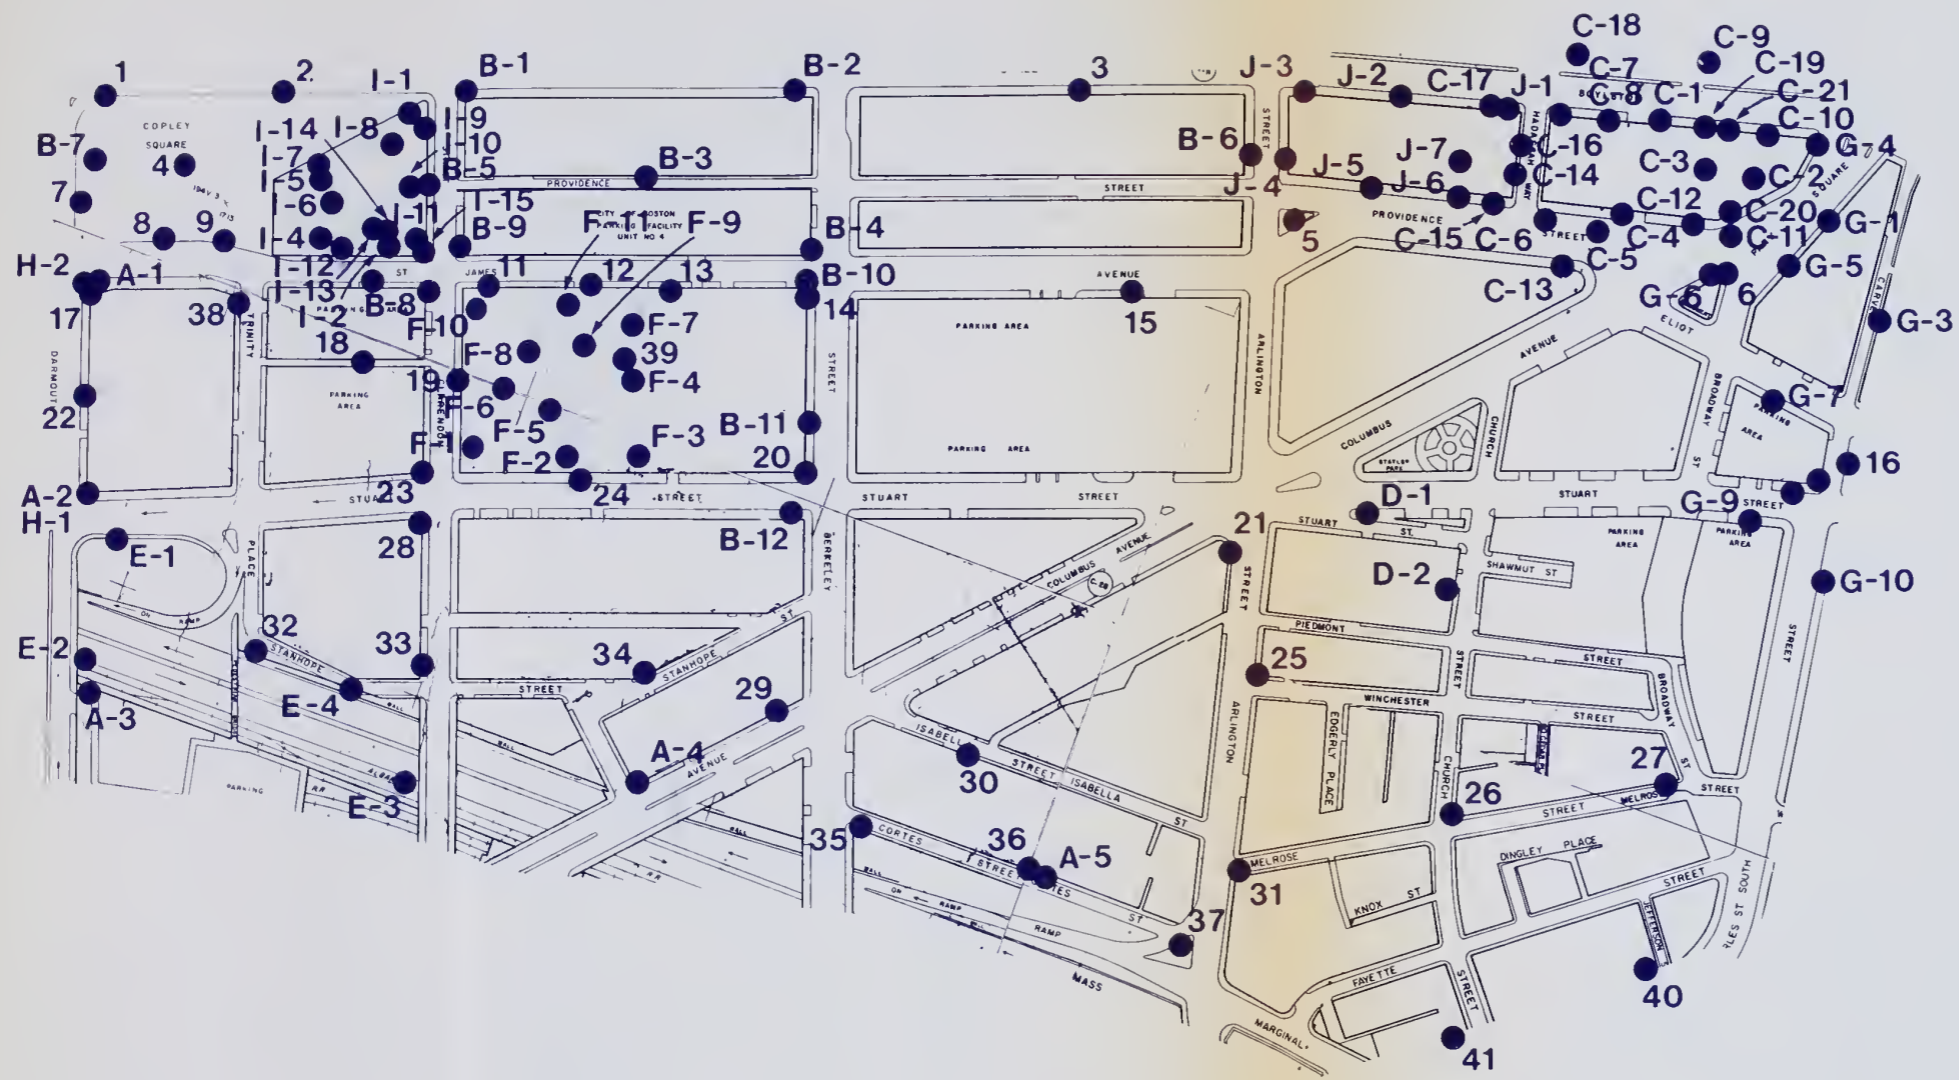
FIGURE 6

- B LOCATION OF WPA OBSERVATION WELL
- C-2 LOCATION OF OBSERVATION WELL INSTALLED AND MONITORED FOR OTHER PROJECTS.

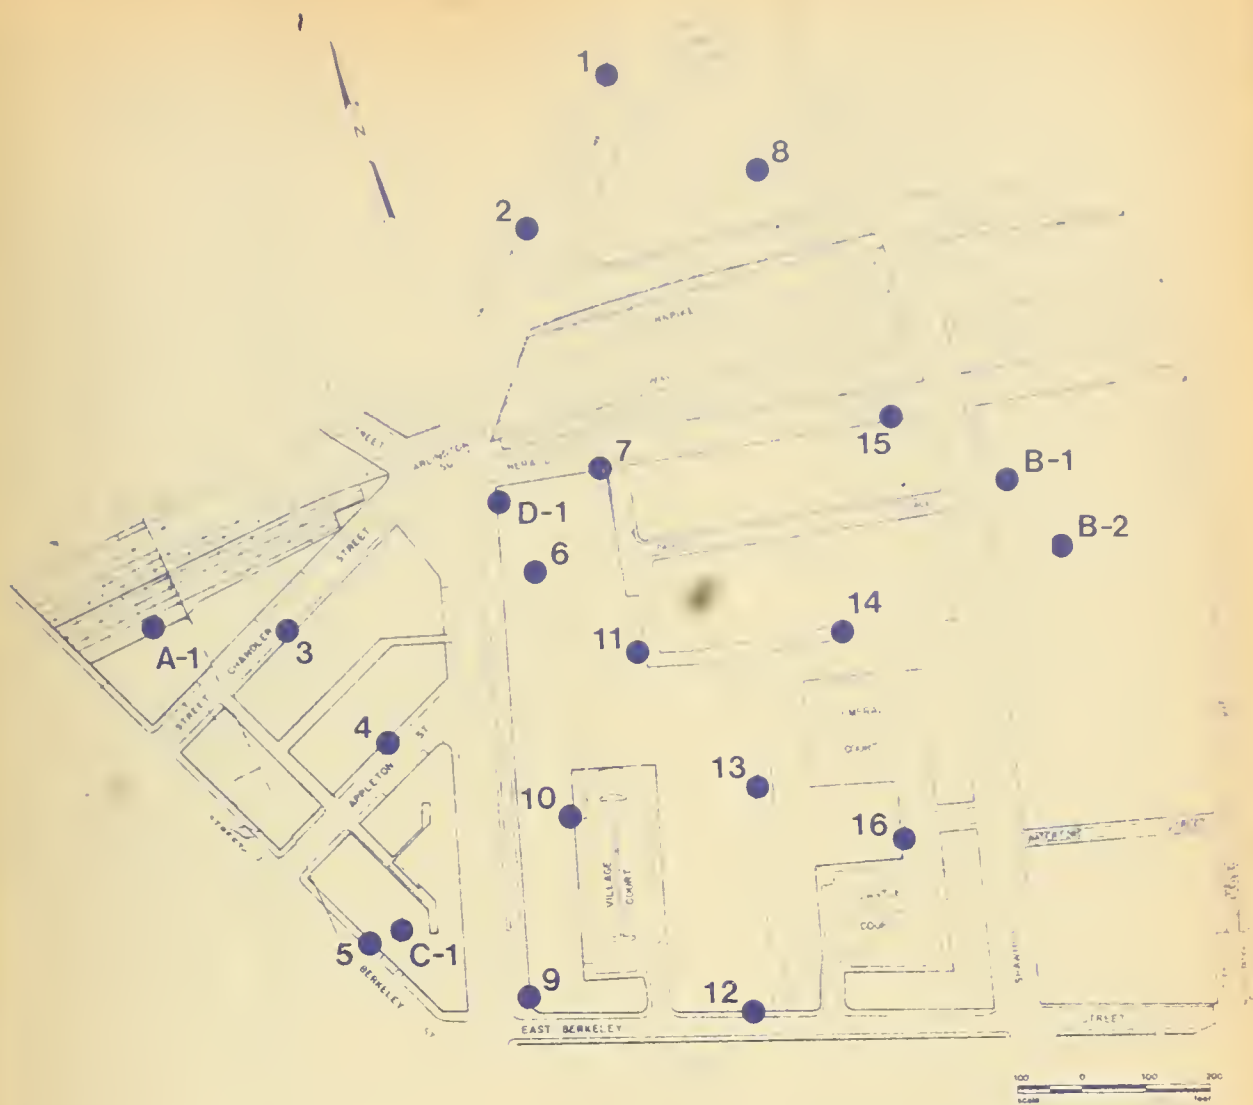
FIGURE 8

- 6 LOCATION OF WPA OBSERVATION WELL
- C-2 LOCATION OF OBSERVATION WELL INSTALLED AND MONITORED FOR OTHER PROJECTS.

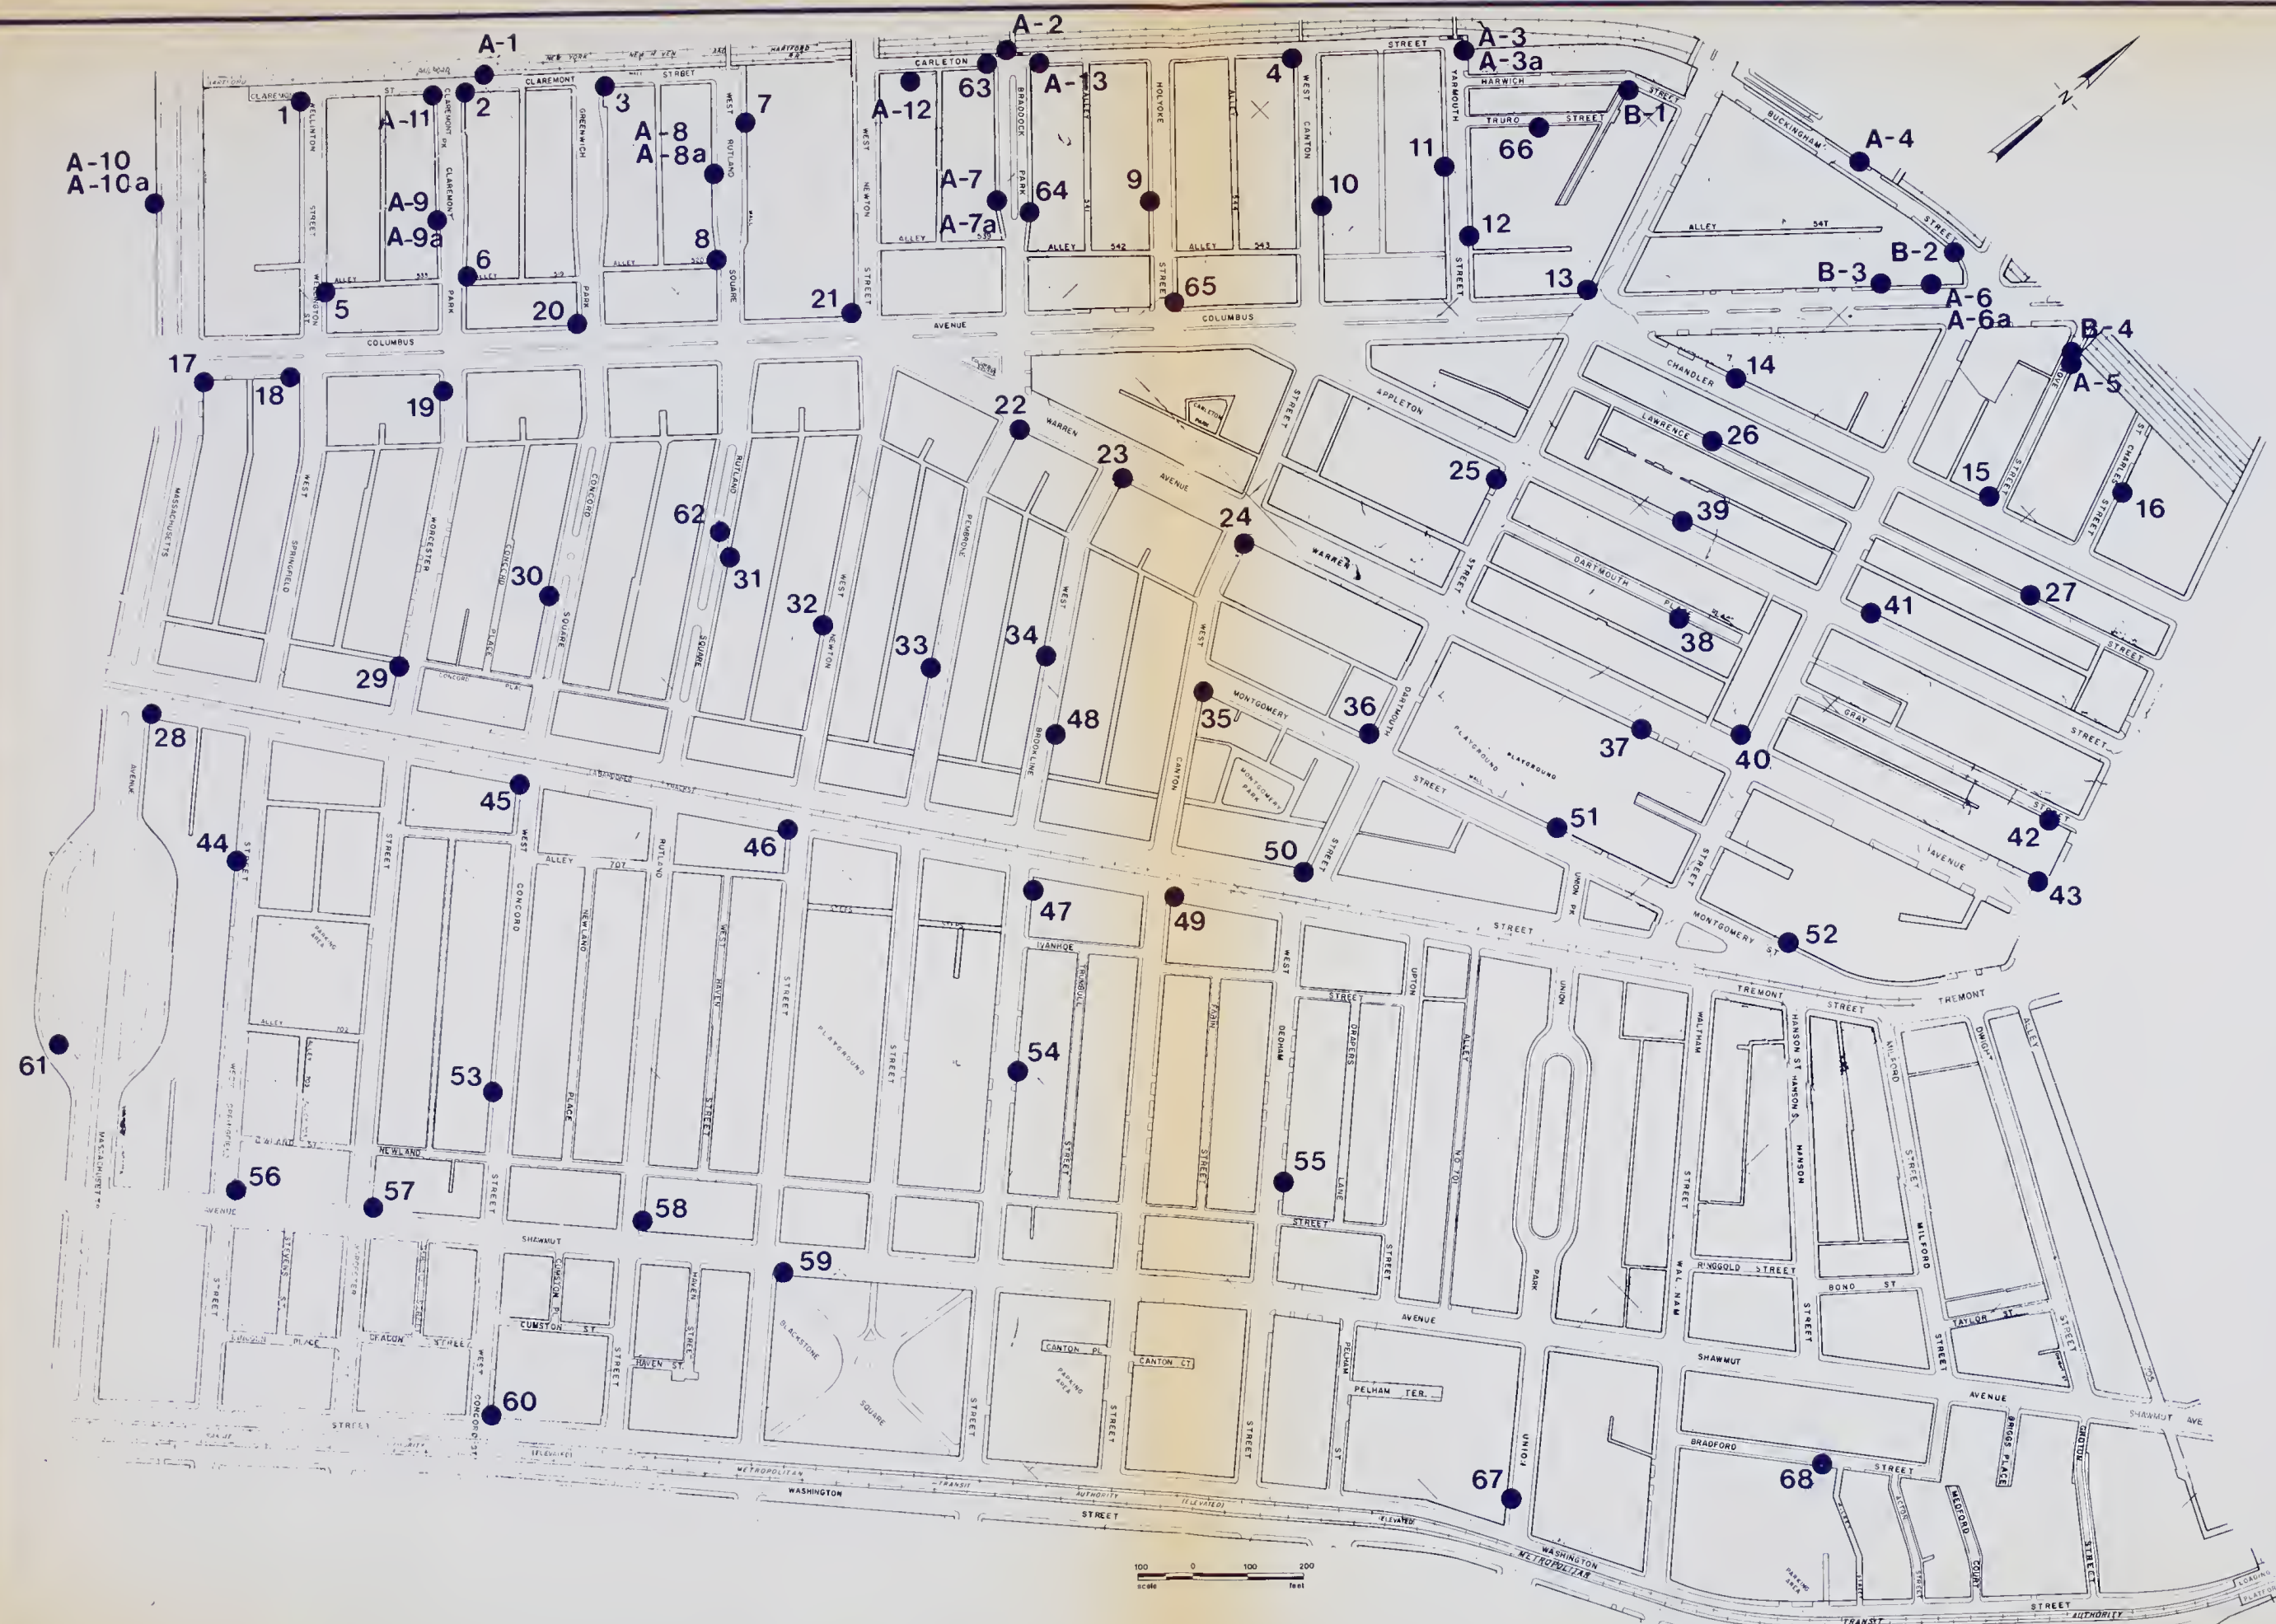
FIGURE 9

- 6 LOCATION OF WPA OBSERVATION WELL
- C-2 LOCATION OF OBSERVATION WELL INSTALLED AND MONITORED FOR OTHER PROJECTS.

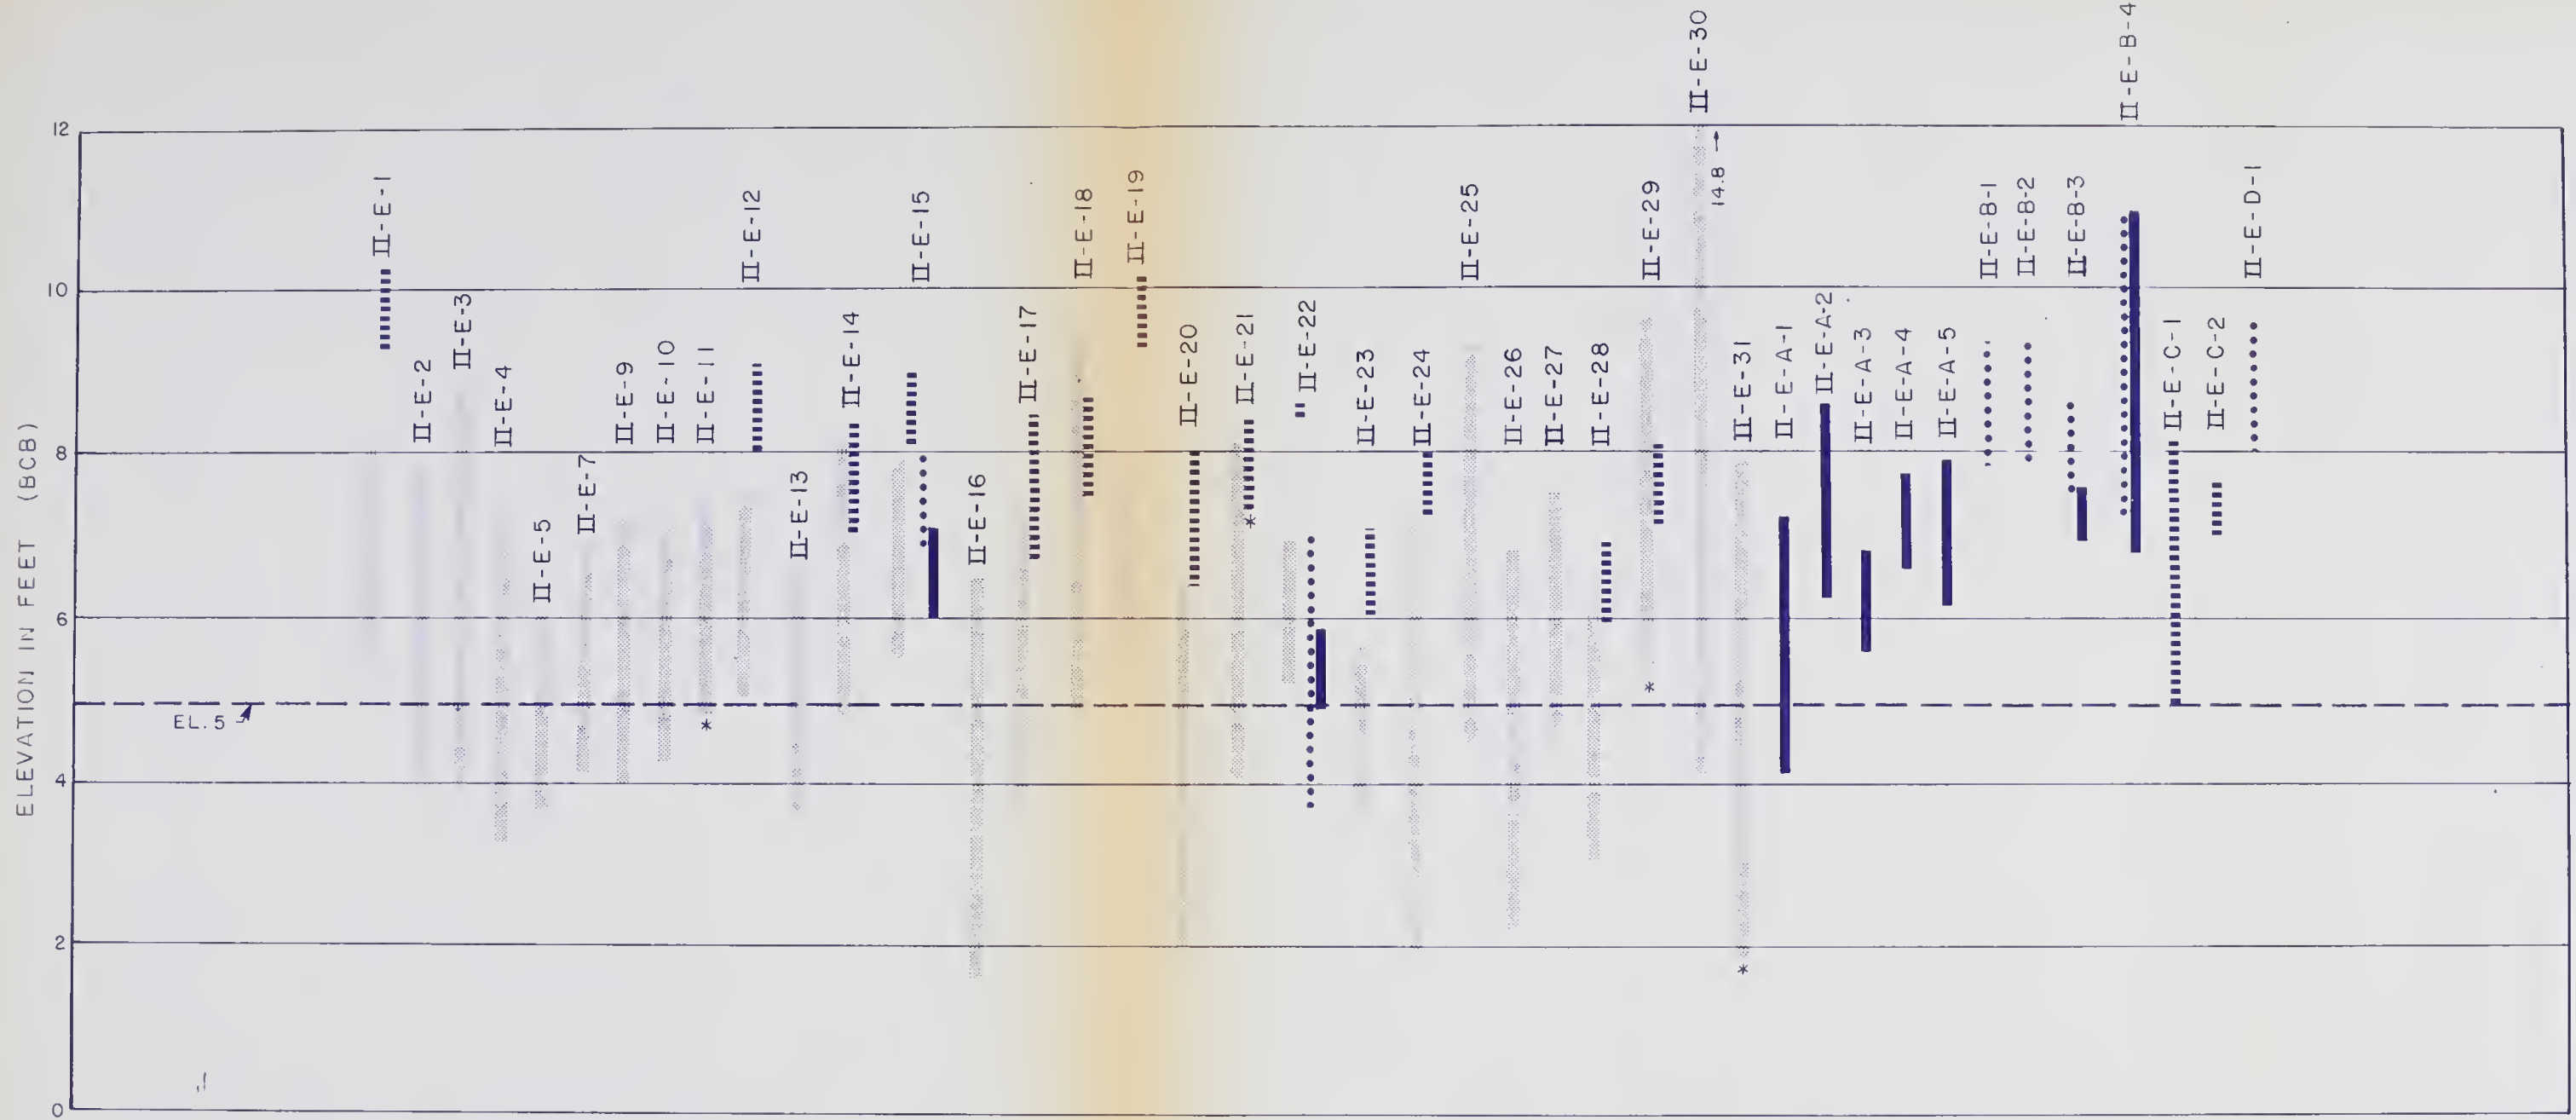
FIGURE 11

1. SEE FIGURE 4 FOR ZONE II-E OBSERVATION WELL LOCATIONS.
2. RANGES OF WATER LEVELS MONITORED IN OBSERVATION WELLS ARE FROM HIGHEST TO LOWEST LEVELS WITHIN EACH MONITORING PERIOD. PREDOMINANT RANGE OF LEVELS MEASURED MAY BE MUCH SMALLER THAN RANGES INDICATED.
3. OBSERVATION WELLS WERE GENERALLY NOT MONITORED FOR EACH YEAR OF THE INDICATED MONITORING PERIODS. WPA OBSERVATION WELLS WERE GENERALLY MONITORED PERIODICALLY FROM 1936 TO 1940, AND IN SEPTEMBER 1967 AND MARCH 1968 BY THE USGS. MONITORING PERIODS FOR "OTHER" WELLS ARE INDICATED ON TABLES II AND IV.
4. REFER TO TABLES III AND IV FOR DETAILS OF EACH OBSERVATION WELL INCLUDING DEPTH, STRATUM, AND WELL TYPE.

**RANGES OF WATER LEVELS MONITORED
 IN ZONE II-E OBSERVATION WELLS**
 NOVEMBER 1984

Data on groundwater levels collected for this study are presented graphically, by zone, in Figures 10 through 16. The data collected were reduced to ranges of groundwater levels measured in each observation well over each of several five-year intervals, as indicated by the bars in the figures. Only the high and low groundwater levels were available from the WPA data (1936 through 1940). The USGS measured groundwater levels in September 1967 and March 1968 and used these data as the lows and highs, respectively.

Ranges, such as presented in Figures 10 through 16, generally provide a reasonable representation of groundwater levels at observation wells but can be misleading with regard to the extremes. Proper interpretation and use of the range data requires an understanding of observation well details, particularly the stratum in which the well tip was placed and whether or not it was sealed in specific stratum. The groundwater levels in the sand outwash often vary from those in the fill and are generally more significantly affected by dewatering for construction or other pumping.

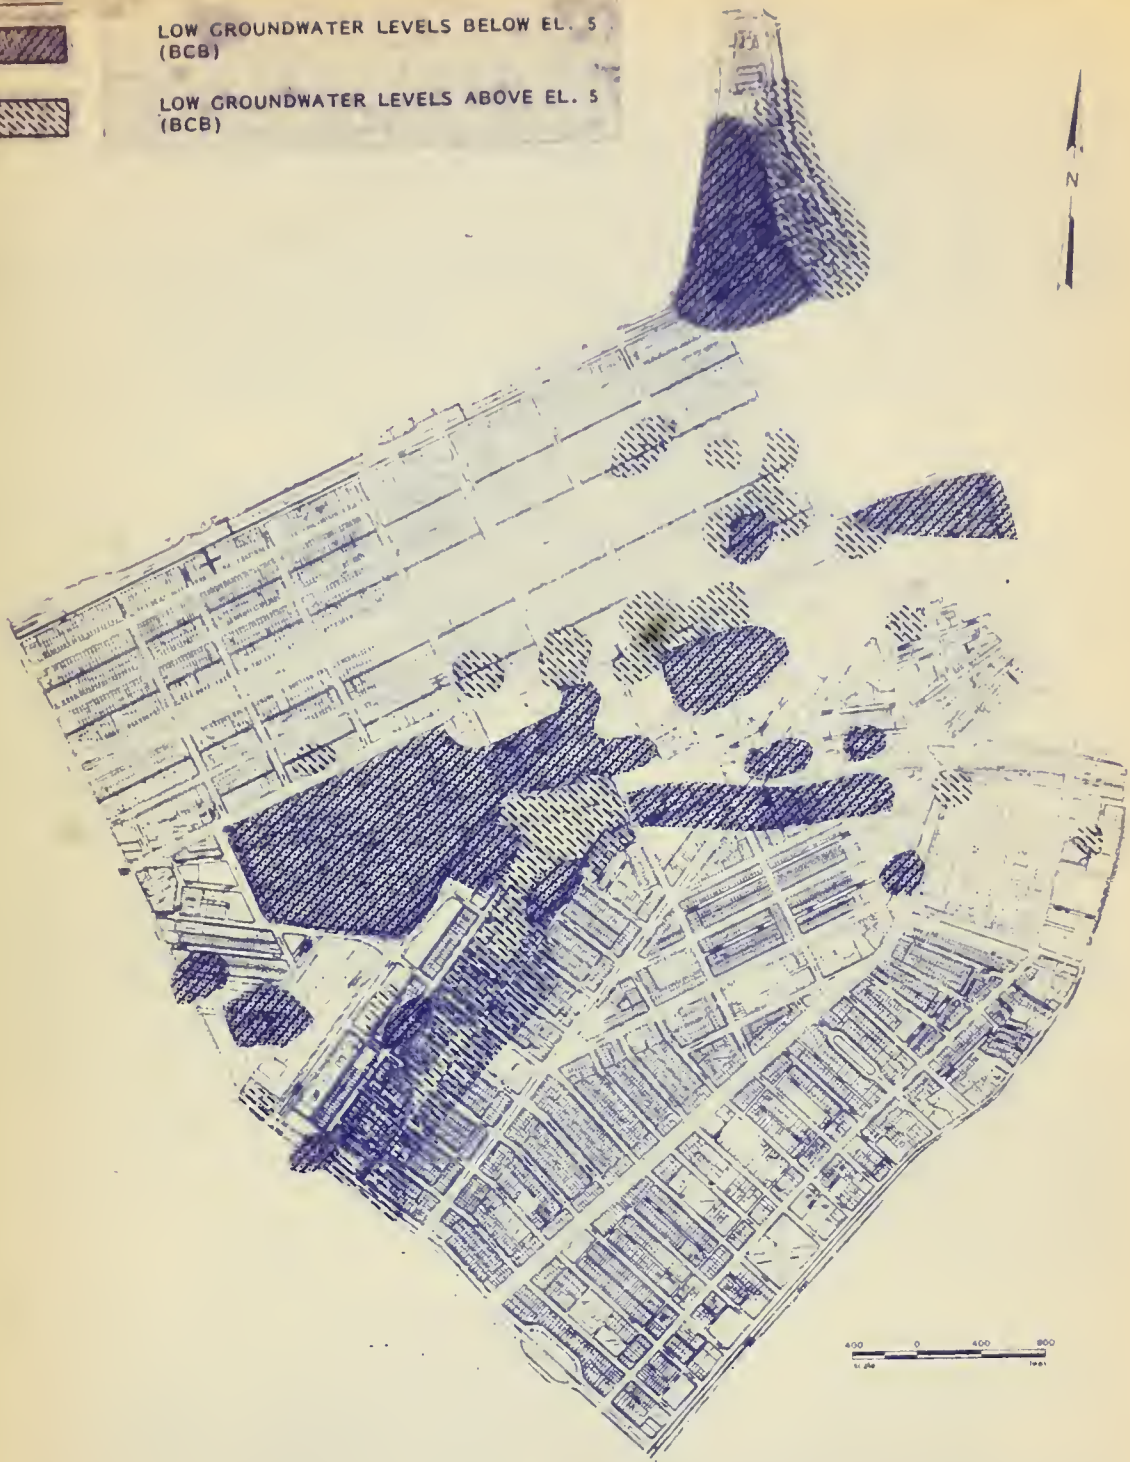
LOW GROUNDWATER LEVELS ABOVE EL. 5 (BCB)

1. THIS FIGURE WAS DEVELOPED USING AVAILABLE DATA PRIMARILY FROM CONSTRUCTION PROJECTS WITHIN THE STUDY AREA SINCE 1970.
2. DATA WERE NOT AVAILABLE IN AREAS THAT ARE NOT CROSS-HATCHED.
3. SOME OW DATA WERE AFFECTED BY DURATION OF MONITORING PERIOD AND/OR NEARBY CONSTRUCTION DEWATERING. SEE REPORT TEXT FOR FURTHER DISCUSSION.

<u>Figure No.</u>	<u>Title</u>
17	Areas Having Groundwater Levels Below El. 5, 1936-1940
18	Areas Having Groundwater Levels Below El. 5, 1967-1968
19	Areas Having Groundwater Levels Below El. 5, 1970-Present
20	Areas of Wood Pile Supported Buildings and Available Post-1970 Groundwater Level Data
21	Recommended Typical Observation Well Detail

Within the past 15 years, groundwater levels have been observed to be below El. +5 in the following major areas: around the John Hancock Clarendon and Berkeley buildings; within the area of the Prudential Complex that is enclosed by a permanent steel sheet pile cofferdam; in the Copley Square area which has experienced chronic problems with leaks into the St. James Avenue sewer; an area along Tremont St. where the historic data indicated widespread groundwater lowering; and recently in the lower Beacon Hill area, probably due to leakage into or along the Boston Marginal Conduit and adjacent sewers.
